**Flood Control Project Maintenance
Levee Inspections****LMA District Cover Sheet
Spring 2016 Levee Inspection Results****Reclamation District No. 2104 Peters Pocket Tract**

Spring 2016 Levee Inspection Results

Reclamation District No. 2104 Peters Pocket Tract

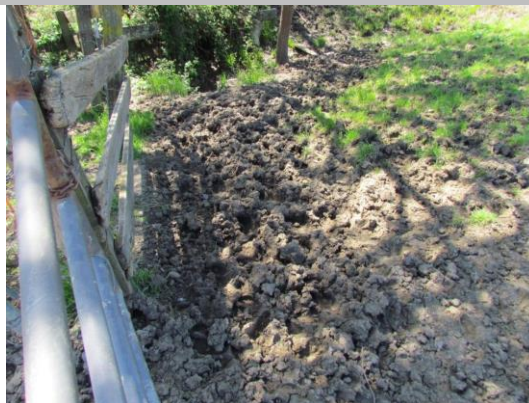
Photo 1 of 1 : SP_2016_RD2104_249_33_20160519_00061.jpg

LM Start	5.35	Rating **	U	Issue No.	33
LM End	5.37	Issue Type +	Ma	Location *	LS
Category	Earthen Levee			GPS Latitude/Longitude	
				Start	End
Item	Erosion / Bank Caving			38.323595 °	38.323730 °
				-121.752295 °	-121.752457 °
DWR ID	DWR_RD2104_01_s_2012_33				
Comment Code					
E1 : Note and monitor erosion site.					
Inspector Comment
